1234 Any Street, Anytown, CA 91724
Inspection prepared for: John and Mary Smith
Real Estate Agent: Top Realtor

Date of Inspection: 5/20/2017 Time: 8:30am
Age of Home: 16 years Size: 1730 sqft
Weather: Warm Sunny - Clear Skies

OrangeCrest Property Inspections
50 W Lemon Ave. Ste 5, Monrovia, CA 91016
Phone: 626-357-7000
Email: info@orangecrestinspections.com
www.orangecrestinspections.com

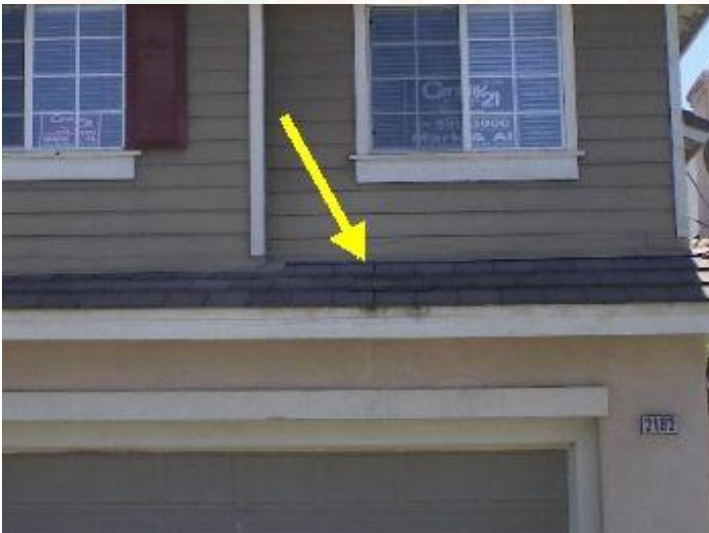
- There are a few cracked roofing shingles noticed above Garage Door (See Photo). Water can penetrate into the interior surfaces. Recommend contacting a qualified licensed roofing professional to replace the damaged shingles.

Location of observed damaged shingles

Page 6 Item: 3	Roof Covering	<ul style="list-style-type: none"> There are a few cracked roofing shingles noticed above Garage Door (See Photo). Water can penetrate into the interior surfaces. Recommend contacting a qualified licensed roofing professional to replace the damaged shingles.
----------------	---------------	---

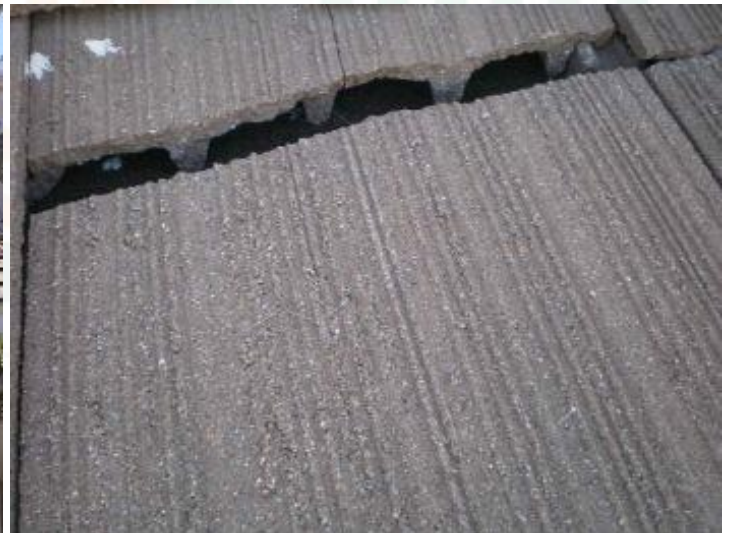
Cracked Roofing Shingle

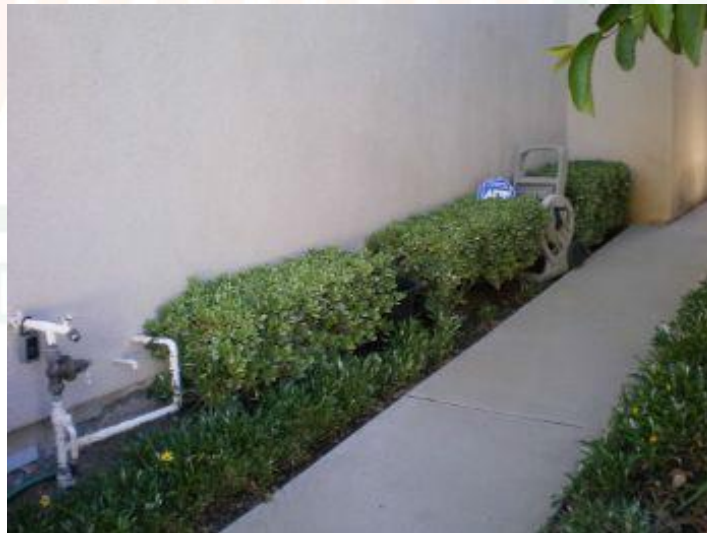
- Appeared functional and satisfactory, at time of inspection.

Walkway to Front Door

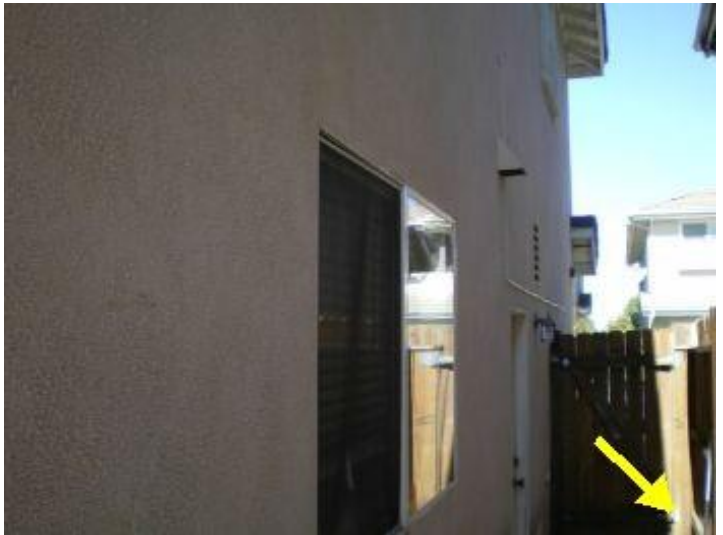
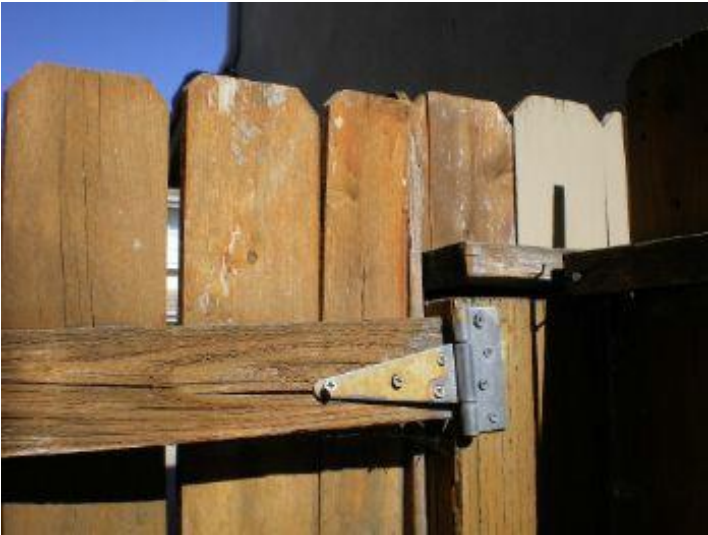
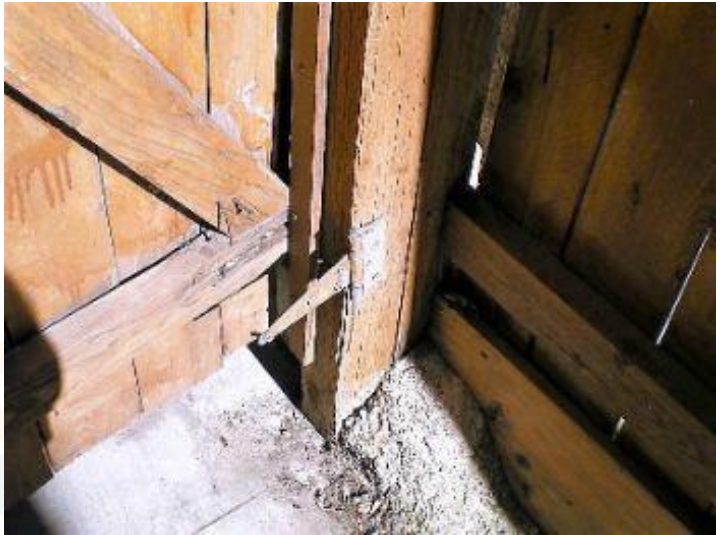
- Minor damage noted to external fence on South side at patio.
- Wood Gate located at North side Walkway is broken and requires repair. Recommend contacting a qualified professional to fix the gate entry.

Gate with broken hinge.

Gate - Upper Hinge

Gate - Lower Hinge - separated from door.

Page 9 Item: 4	Fence/Gates	<ul style="list-style-type: none"> Wood Gate located at North side Walkway is broken and requires repair. Recommend contacting a qualified professional to fix the gate entry.
----------------	-------------	---

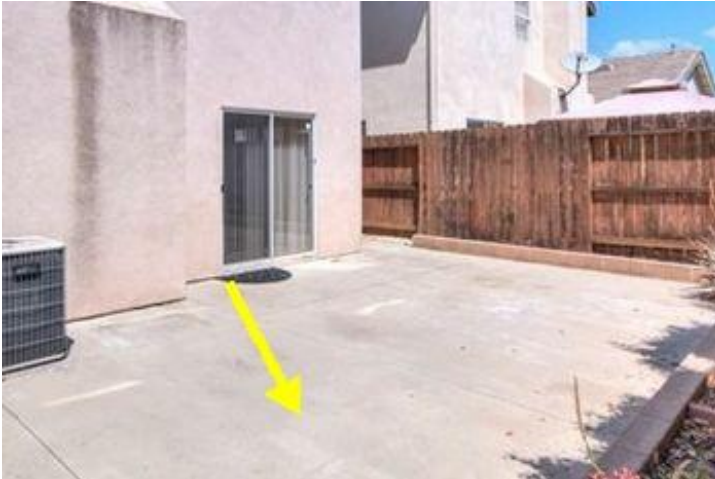
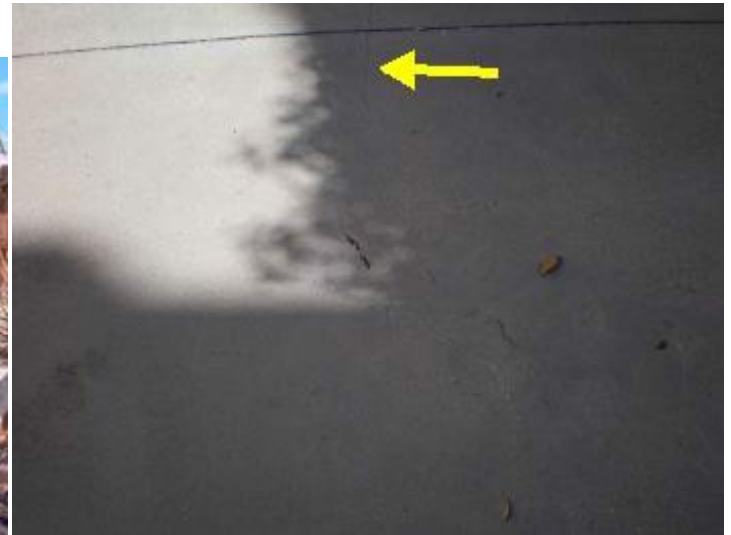
- Typical cracking was observed at the concrete surfaces. Further deterioration will occur as water expands and contracts from weather cycles. Recommend sealing the cracks to prolong the life of the concrete.

Side Patio - Noted hairline crack

Hairline crack

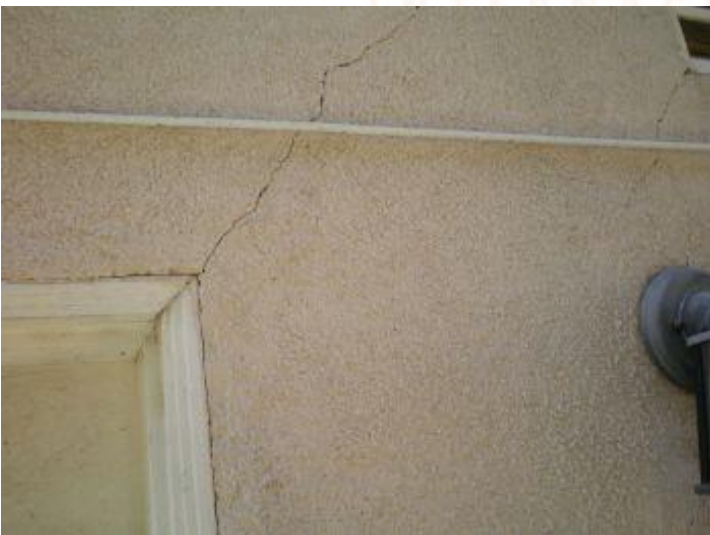
- Typical hairline cracking observed around a number of windows, vents, and garage side access door. Recommend contacting a qualified professional for sealing of noted cracks to better prevent water intrusion.
- Moderate staining observed at multiple locations on exterior cladding(walls).

Representative sample of hairline cracks observed.

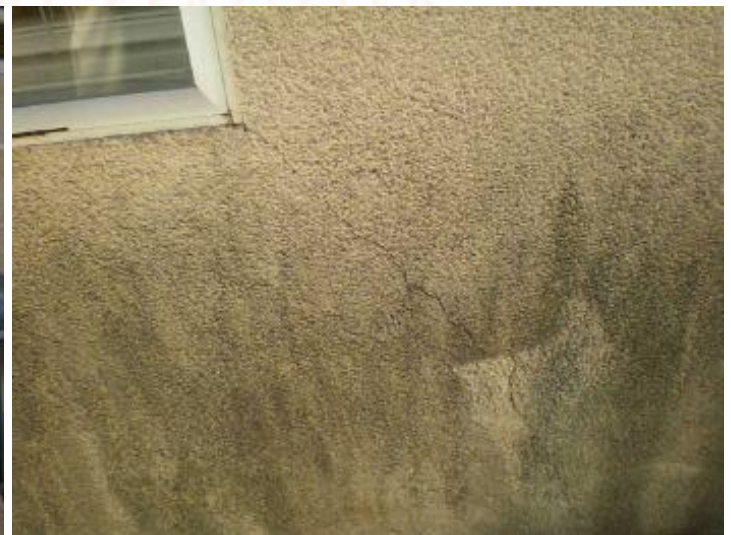
Representative sample of visible staining at exterior walls

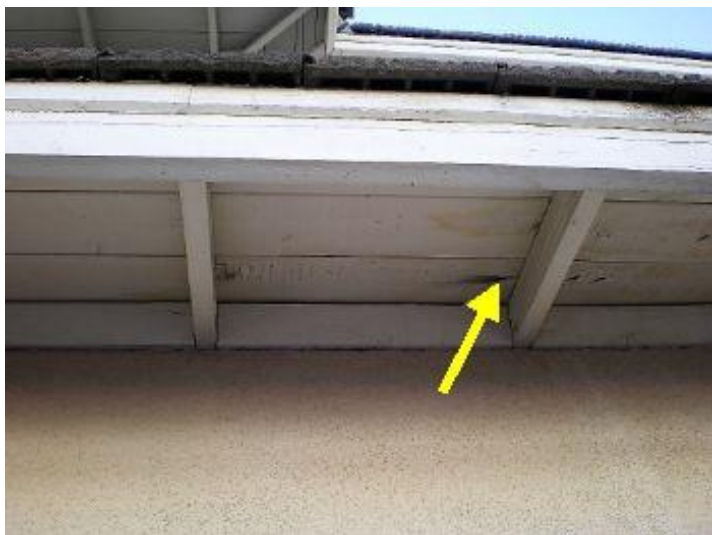
- No deficiencies noted at time of inspection.
- Noted: Severed hanging cable and peeling paint above overhead garage door at eave.
- Noted: Stain above side patio at eave.

Eave above overhead garage door

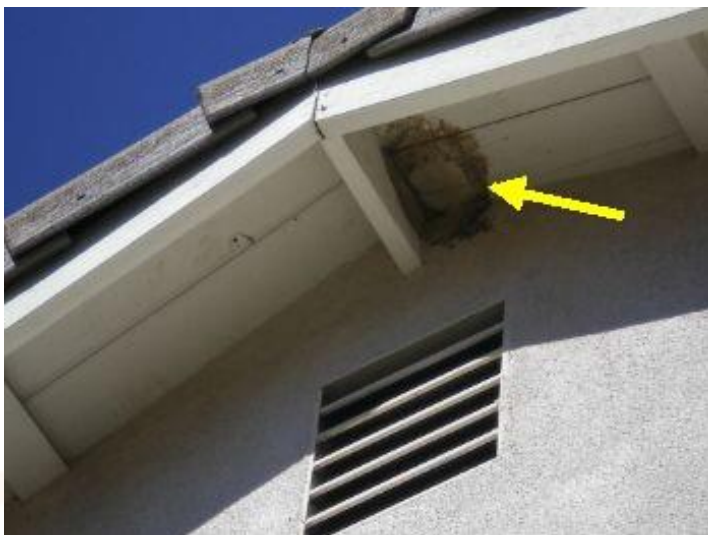
Above Patio -Visible stain at eave

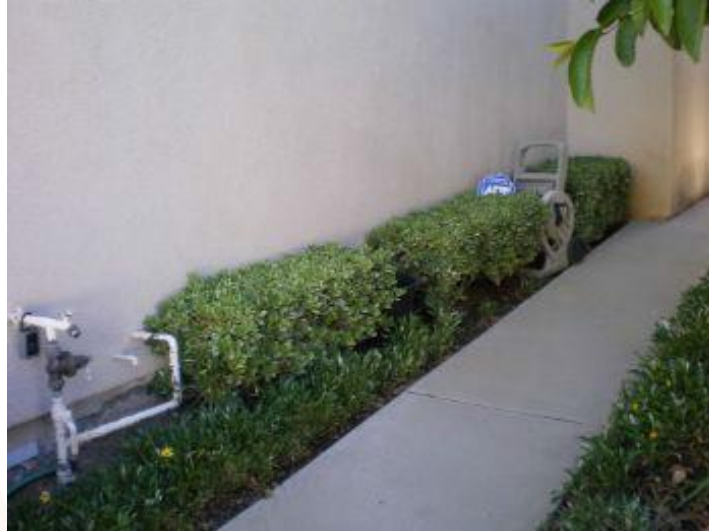
- Vegetation observed along south garage wall/front walkway. Such a condition can lend to damage and deterioration by root growth and/or attachment, and moisture retention.

Hedges against south wall at main walkway

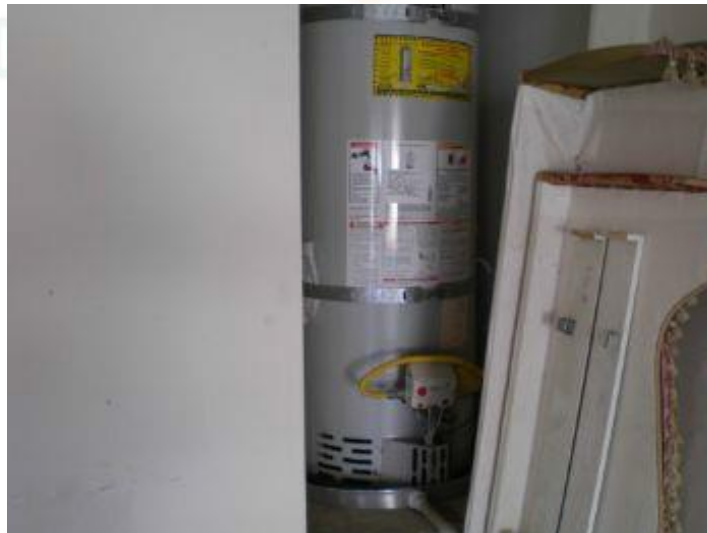
- The garage had some storage and clutter at the time of inspection.
- Typical staining was observed on the concrete garage floor.
- SAFETY CONCERN: Flammable materials should not be stored within closed garage areas.

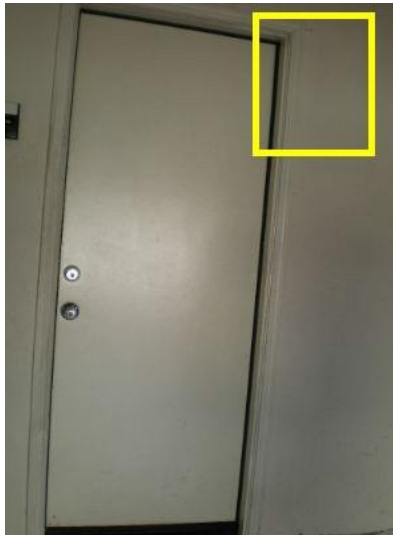
- There is no self-closing device on the door from the house leading to the garage. It is strongly recommended that one be installed in order to protect the residence against garage originated fires.

Absence of self closing device on Fire Door

Page 14 Item: 4	Garage Firedoor	<ul style="list-style-type: none"> There is no self-closing device on the door from the house leading to the garage. It is strongly recommended that one be installed in order to protect the residence against garage-originated fires.
Page 14 Item: 5	Garage Firewall and Ceiling	<ul style="list-style-type: none"> Vent piping for the water heater is improperly sealed at the garage ceiling. For fire safety, any openings around pipes that penetrate the ceiling need to be collared and sealed appropriately.

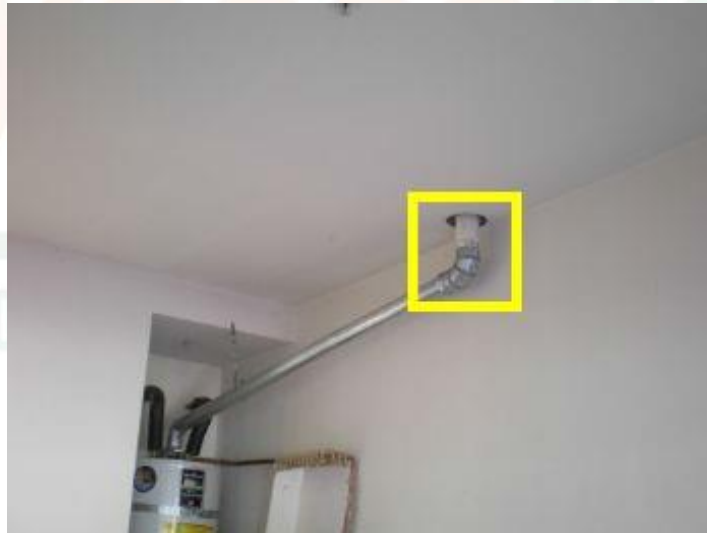
- Vent piping for the water heater is improperly sealed at the garage ceiling. For fire safety, any openings around pipes that penetrate the ceiling need to be collared and sealed appropriately.

Water Heater Vent Pipe at Ceiling Penetration

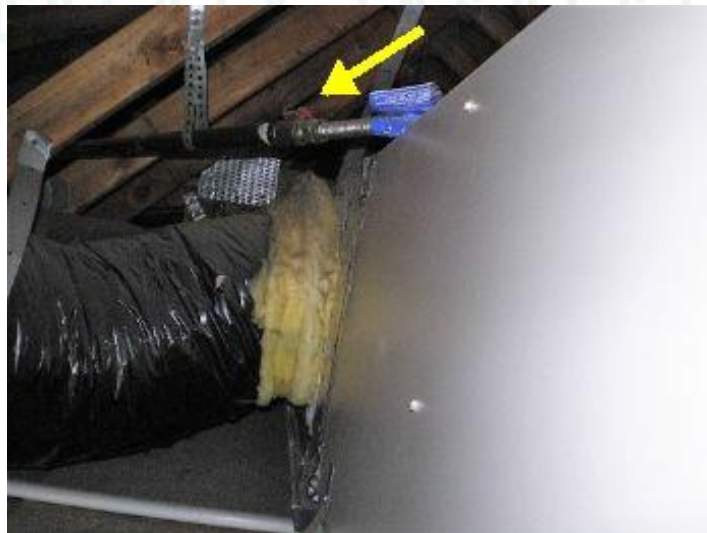
- No deficiencies observed.
- Annual/seasonal HVAC service contract highly recommended.
- No record of recent service observed.
- The emergency drain pipe from attic furnace was noted, but could not be fully inspected due to accessibility limitations within the attic.
- Emergency Shut Off Valve present and identified via photo in report.

Emergency Gas Shut Off for Heating Unit

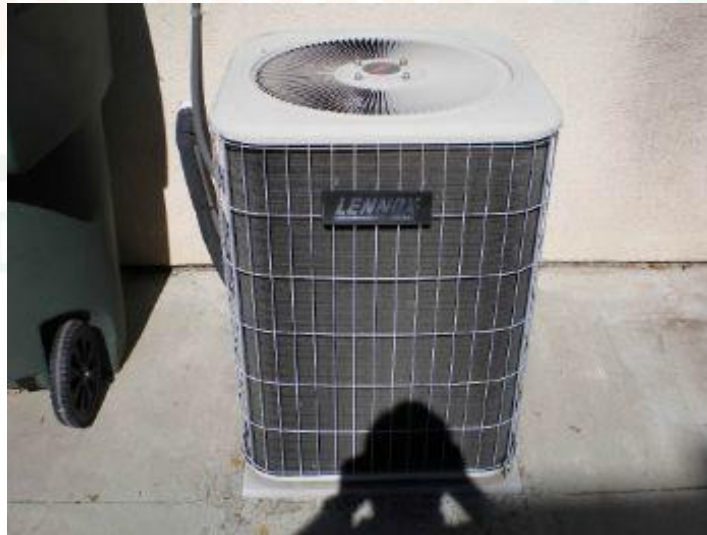
- No deficiencies noted at the time of inspection.
- Annual/Seasonal professional HVAC inspection and cleaning services are recommended.
- No record of recent service observed.

Central Air Unit

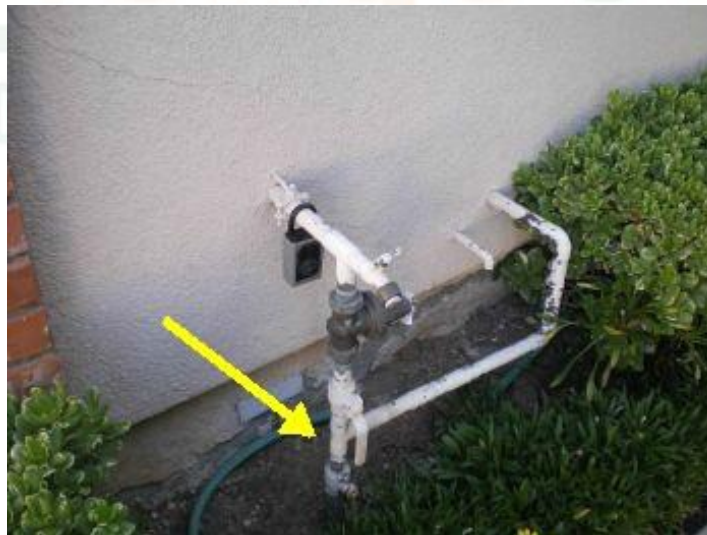
- Water shut off valve (See Photo)

Main Water Shut Off at front Walkway

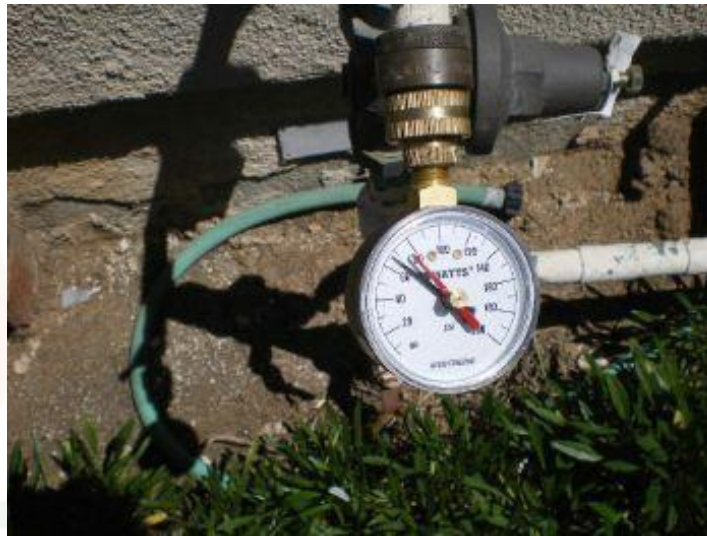
- The water pressure was tested and was found to be approximately 70PSI.

Water Pressure Gauge reading approximately 70 PSI

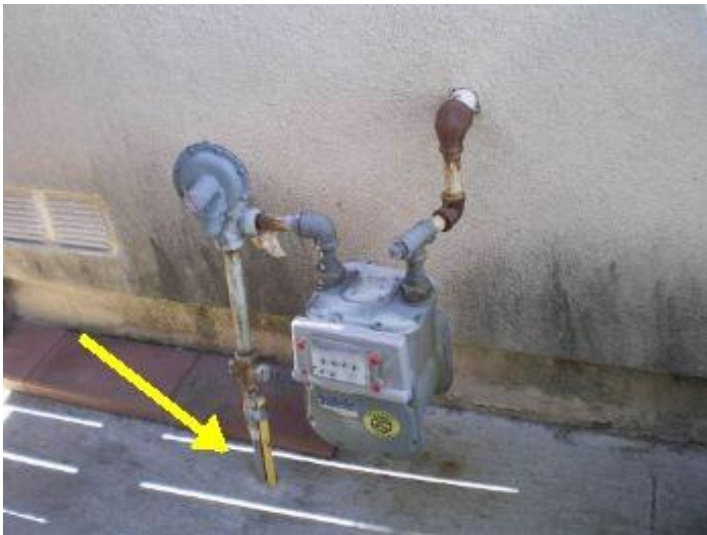
- Meter located at exterior. All gas appliances have shut-off valves in line at each unit. No gas odors detected.
- No deficiencies observed at the visible portions of the gas supply piping at the time of inspection.

Gas Meter - Main Gas Shut Off Exterior North West of House

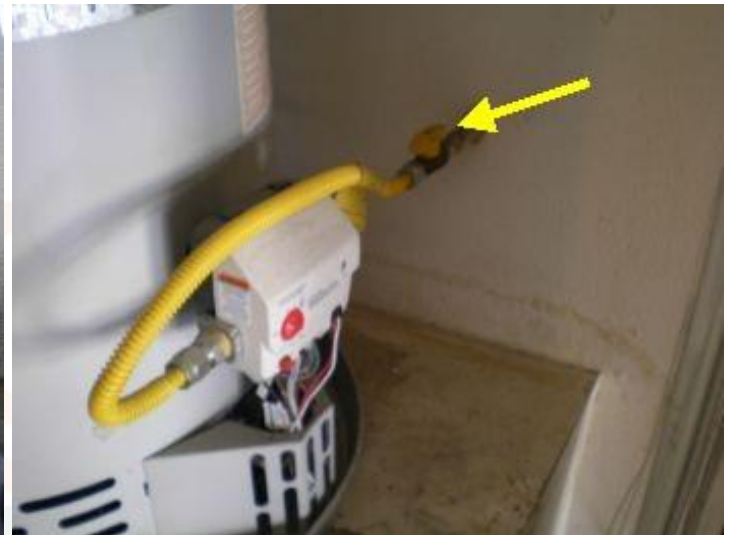
Water Heater - Gas Shut Off - Garage

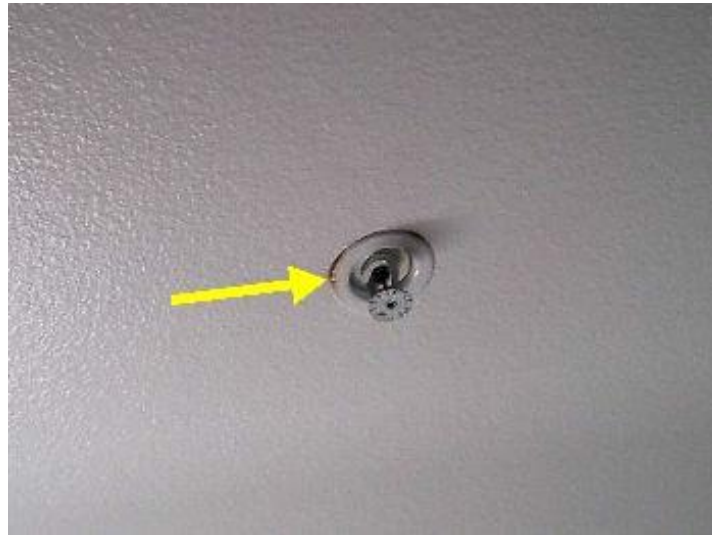
Observations: Minor discoloration noted at fire sprinkler upstairs. Typically fire safety systems are inspected and maintained by a qualified licensed professional annually. Fire safety systems are outside of the scope of a standard home inspection.

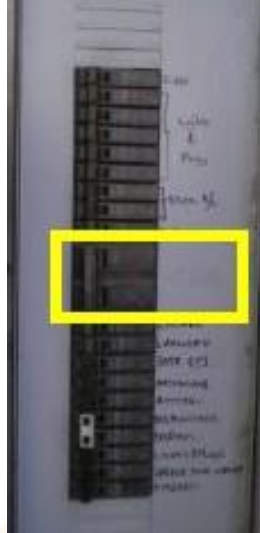
- Main electrical disconnect at the 200 amp circuit breaker on panel. See photo below.

Fuse Box - Main Disconnect Breaker

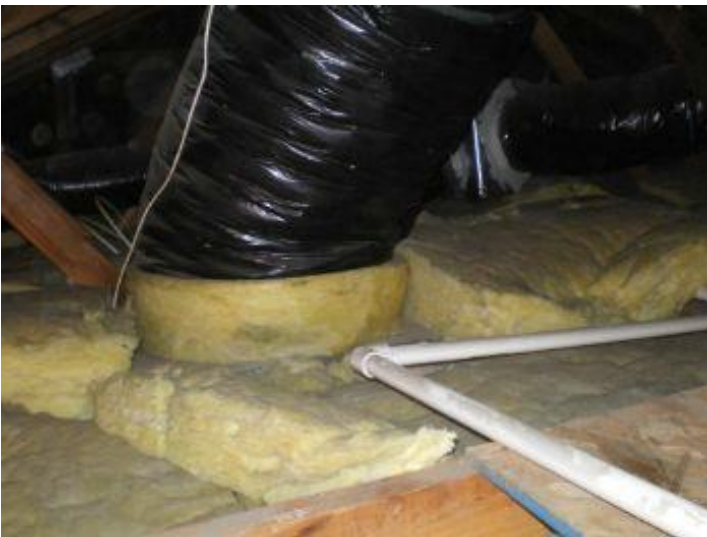
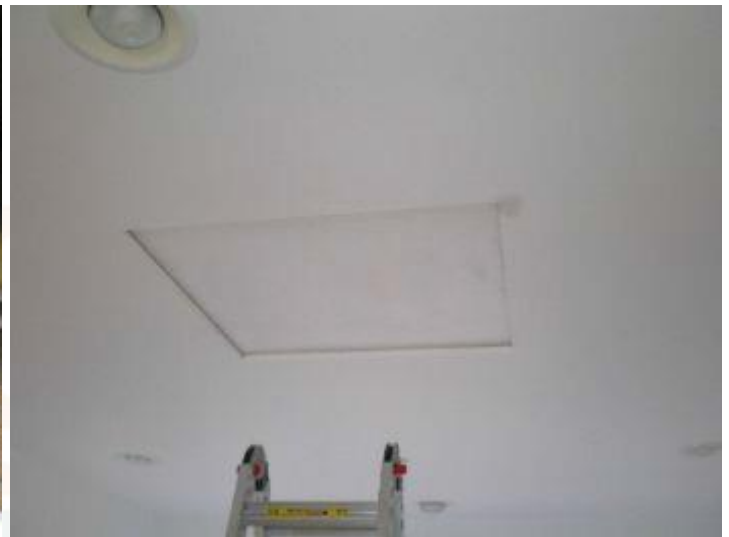
Observations: The attic access is not insulated. Expect some energy loss through convection. Recommend insulating attic access hatch cover.

Limited visibility/access

Upper Level - Attic Hatch

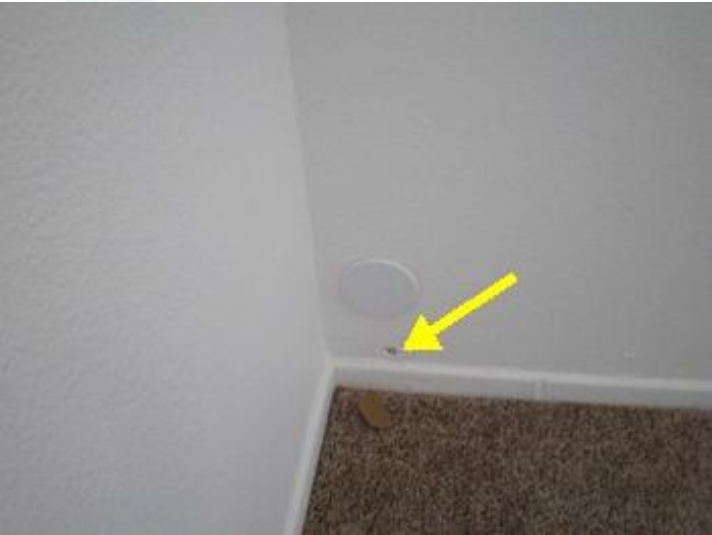
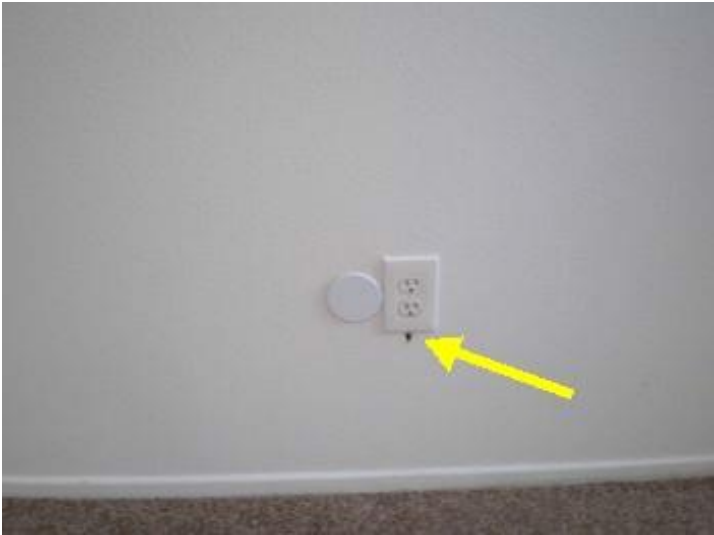
- General condition of walls and ceilings appeared satisfactory. Exceptions noted.
- Some cosmetic, small holes noted in wall(s). Located in Upper Level Bedroom(s).
- Minor damage in Upper Level Bedroom #3 (South-West) floor moulding.

Minor hole in #4 Bedroom

Minor hole in #1 Master Bedroom

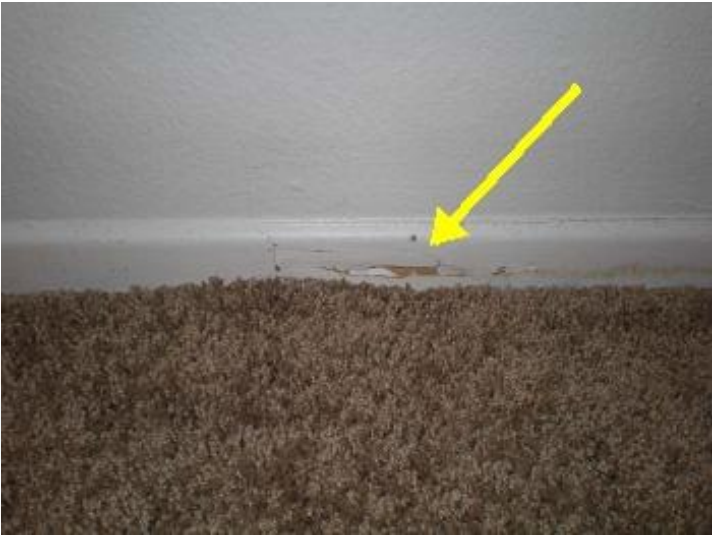
Minor damage visible at floor moulding

Page 29 Item: 2	Walls and Ceilings	<ul style="list-style-type: none"> Minor damage in Upper Level Bedroom #3 (South-West) floor moulding.
-----------------	--------------------	---

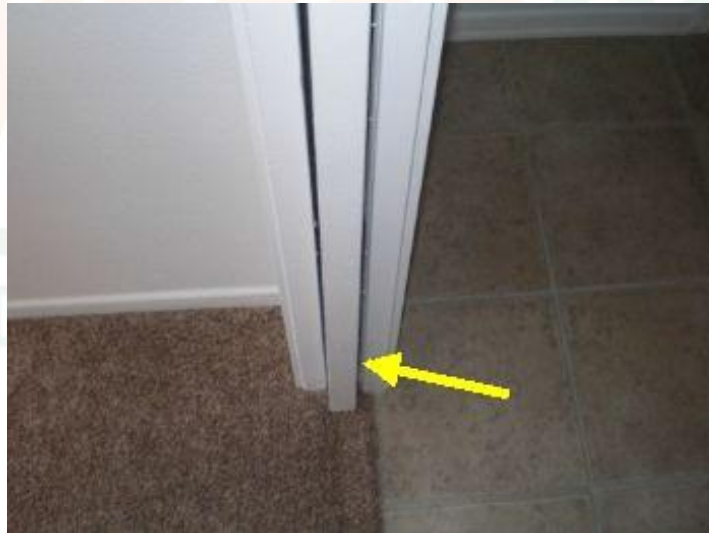
- Appeared functional, at time of inspection - except as noted.
- Pocket door located in Upper Bathroom #2 is missing guides at the floor. Door is functional and operates without guide.

Pocket Door at Upper Level #4 Bedroom

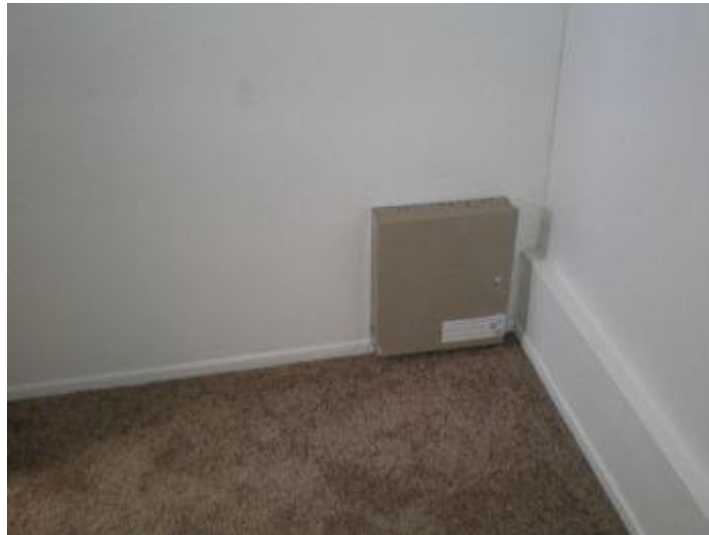
- Appeared functional, no deficiencies noted at time of inspection.
- Security system control box noted in master bedroom closet at floor.

Master Closet - Security System Control Box

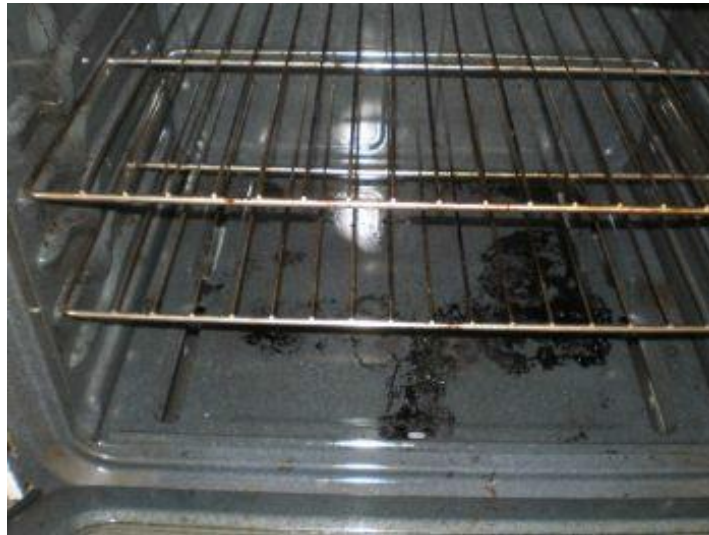
- All heating elements operated when tested.
- Bottom of oven showed signs of typical staining.

Kitchen - Interior Oven

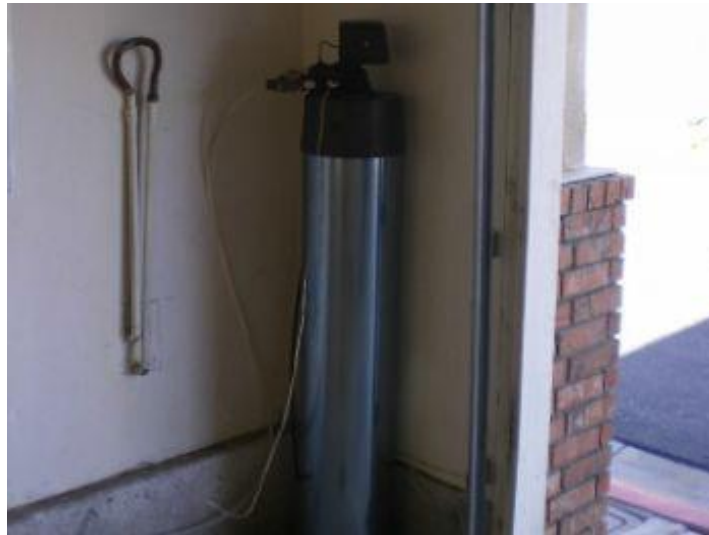
Observations: Water filtration system disconnected, and not operated at time of inspection.

Water Filtration Tank - Stored in Garage

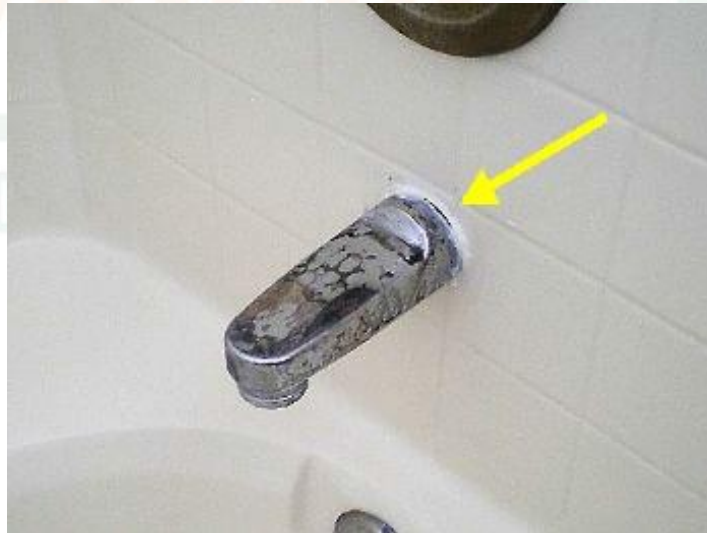
- All edges and tub/shower walls should be periodically checked -- then caulked and sealed as necessary to prevent moisture penetration.
- Noted deficient caulking at shower faucet in Master Bath, recommend repair as necessary to prevent moisture penetration.

Master Bath - Shower Faucet

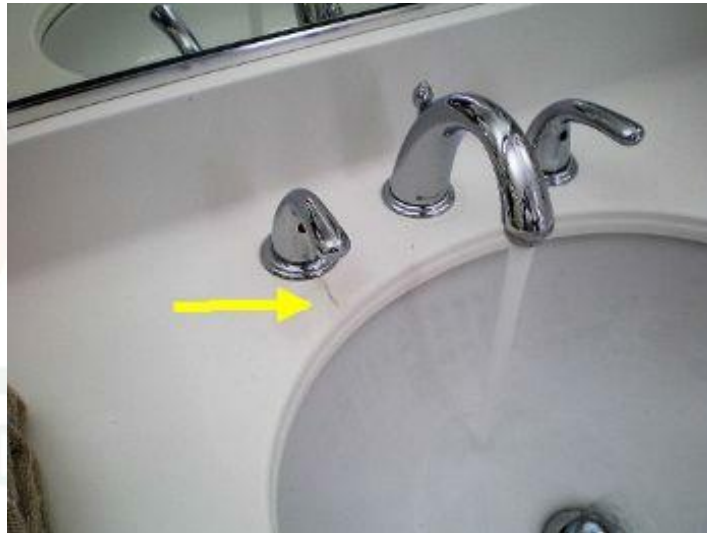
- Countertop shows signs of normal wear - cosmetic scratch at left faucet (Upper Level - Master Bath).

Master Bath - Scratch at countertop

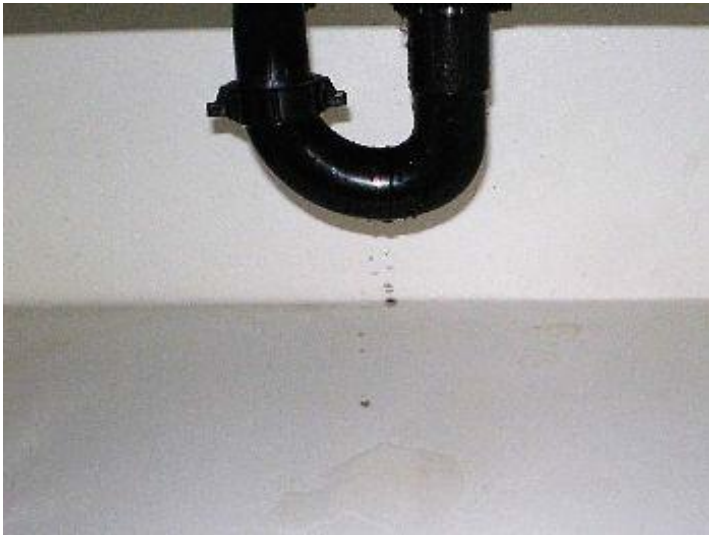
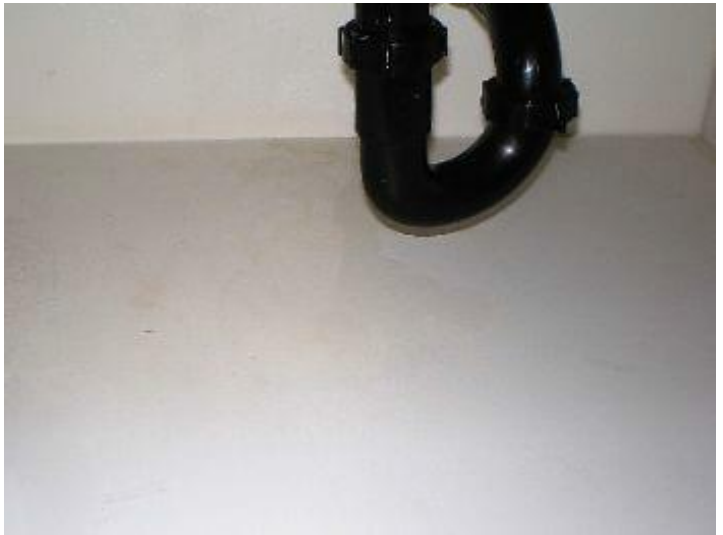
- Upper Bathroom #2 - Noted leaks under both sinks. Recommend qualified licensed plumber repair to prevent water penetration.

Water leaking from Bathroom #2 Left

Water leaking from Bathroom #2 Right

Page 35 Item: 1	Tub(s)	<ul style="list-style-type: none"> Some minor repair needed at tub in #2 Hall Bath. Minor penetration observed at the base of north side of tub. Repair or replace to avoid water damage.
Page 35 Item: 2	Shower(s)	<ul style="list-style-type: none"> Noted deficient caulking at shower faucet in Master Bath, recommend repair as necessary to prevent moisture penetration.
Page 36 Item: 8	Sinks	<ul style="list-style-type: none"> Upper Bathroom #2 - Noted leaks under both sinks. Recommend qualified licensed plumber repair to prevent water penetration.
